Airport Master Plan

Montgomery-Gibbs
Executive Airport

Pavement
Maintenance
Management
Plan (PMMP)
2018

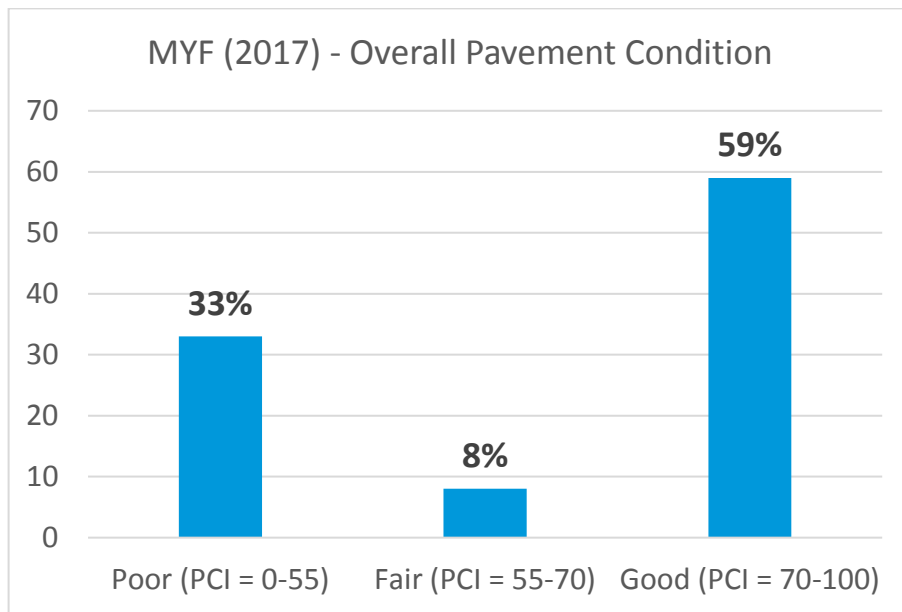
Figure 3-2 Overall Pavement Condition (August 2017)

The overall condition of the airfield pavements at Montgomery-Gibbs Executive Airport in 2017 is shown in **Figure 3-2**. The majority (67%) of airfield pavements are in fair to good condition. The remaining 33% of airfield pavements are in poor condition and needs a rehabilitation or re-construction. As shown in **Figure 3-2**, the average PCI values for runways, Runway 28R stopway, taxiways and aprons are 85, 93, 71, and 53, respectively. The area-weighted PCI for combined airfield pavements including runways, Runway 28R stopway area, taxiways and aprons is 75.

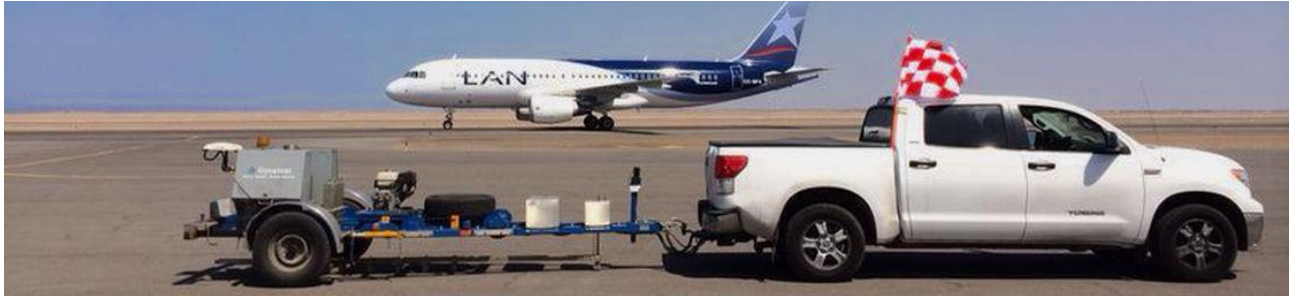
Figure 4-1 Dynatest Heavy Weight Deflectometer

To better assess the structural integrity and the load-carrying capacity of the Montgomery-Gibbs Executive Airport pavements, a Non-Destructive Testing (NDT) utilizing a Heavy Weight Deflectometer (HWD) as shown in **Figure 4-1** was performed. The detailed testing plan and location can be found in **Appendix E**.

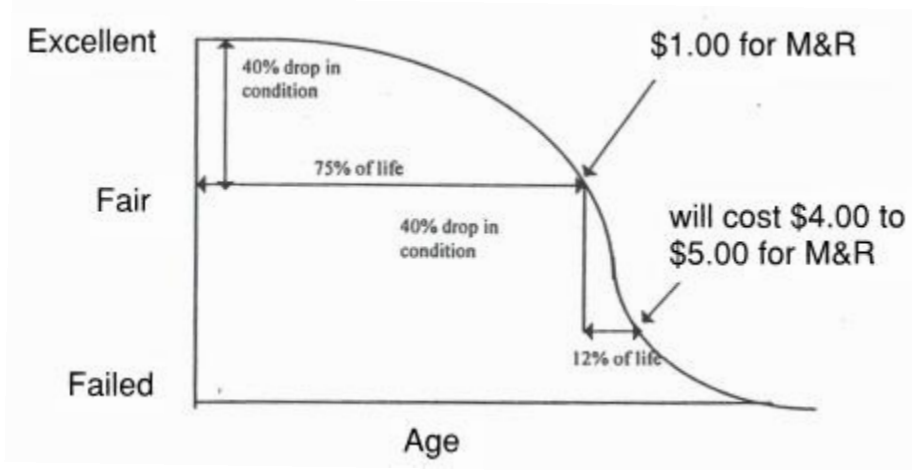
Figure 5-1 Standard Pavement Deterioration Curve

A typical pavement performance curve is illustrated in **Figure 5-1**. The pavement deterioration rate in general is slow when the condition is newer. It takes approximately three-quarters of the pavement life to reduce its condition by 40%. However, it only takes a short amount of time (e.g. 12% of pavement life) to decrease an additional 40% of its condition. Assuming no budget is available for maintenance and rehabilitation, the predicted PCI for all airfield pavements of Montgomery-Gibbs Executive Airport in the next 5 years is shown in **Table 5-1**. The predicted PCIs for each branch of airfield pavements are shown in **Figure 5-2** through **Figure 5-4**.

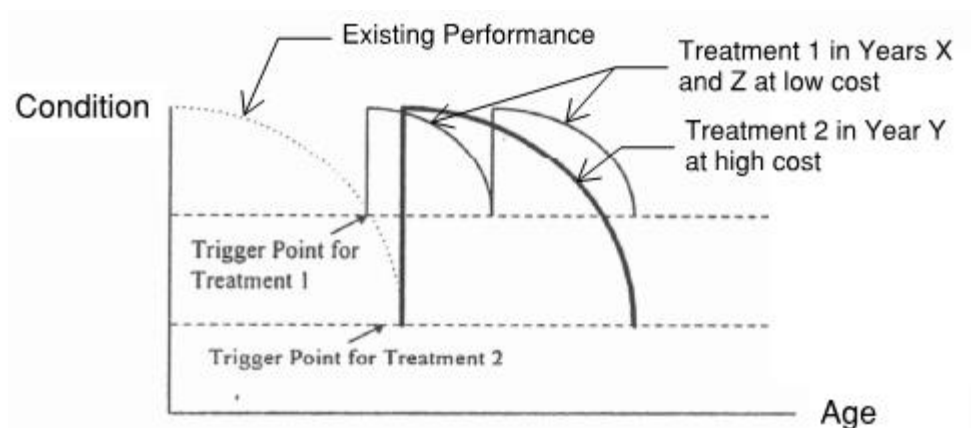
Figure 5-5 Timing of Treatment

The most economic approach for pavement maintenance is to keep pavements in good repair. As illustrated in **Figure 5-5**, it is more cost effective to apply a low-cost treatment when a trigger point (critical PCI value) for Treatment 1 is reached. In other words, Treatment 1 can be applied multiple times throughout the pavement life once the critical PCI value is reached. If the right timing of treatment is missed, costly Treatment 2 will need to be applied to restore the pavement condition and to extend the pavement life. As shown in **Figure 5-5**, both options (Treatments 1 and 2) would extend the same amount of the pavement life. The higher cost Treatment 2 does not warrant a longer pavement life as the rate of deterioration increases significantly after the PCI drops below the critical value.

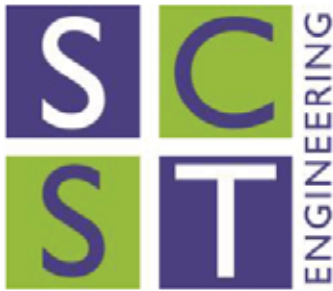
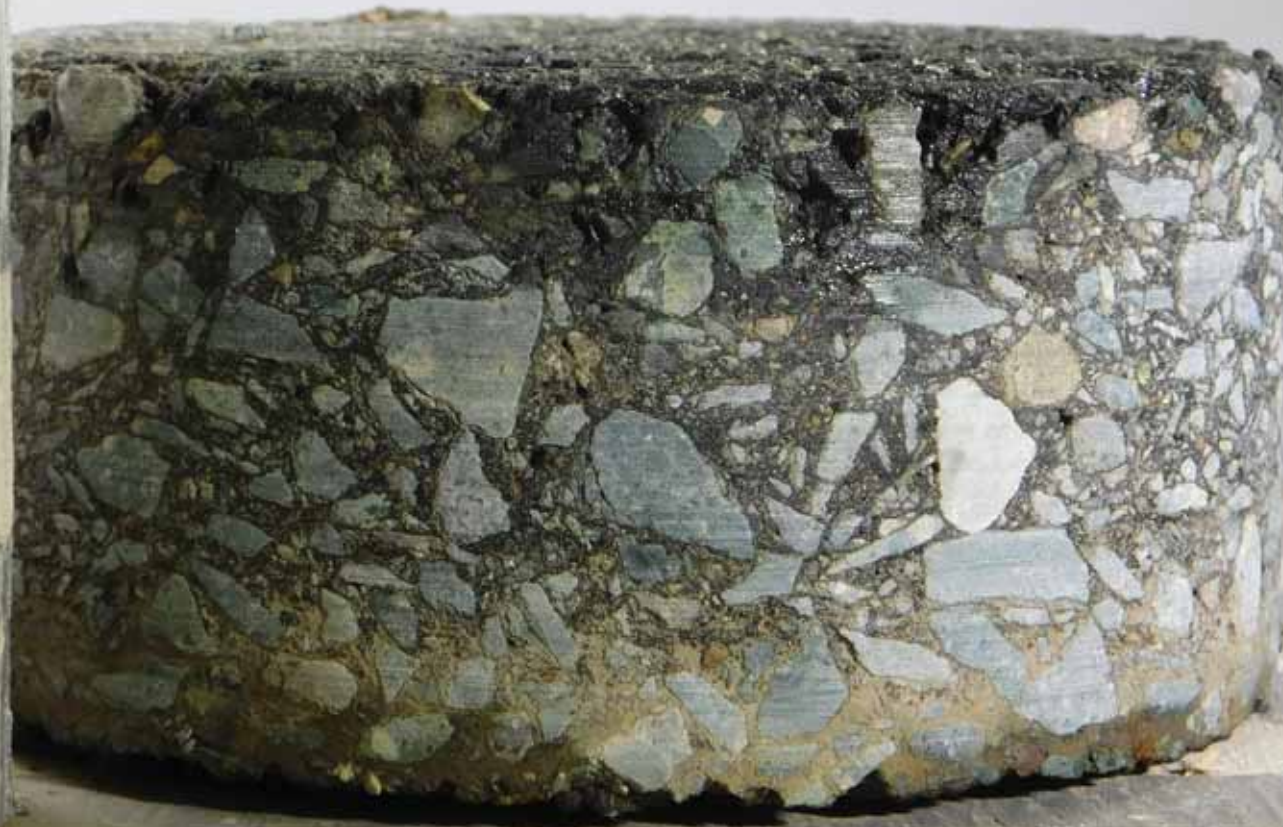
Location	Total AC Thickness (inches)	Notes
C-1	2¾	
C-2	3	
C-3	4½	
C-4	3¾	
C-5	6½
